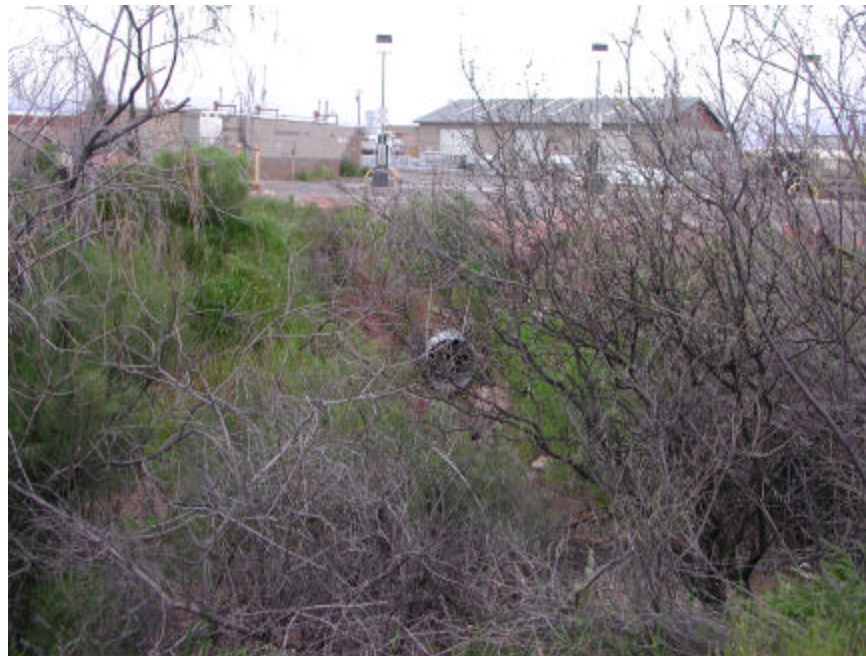
Outfall Identifier: 260-352.33
Description: 36" CMP outfall into west bank of Verde River tributary north of SR-260.
Photograph orientation: Looking west into wash and pipe.

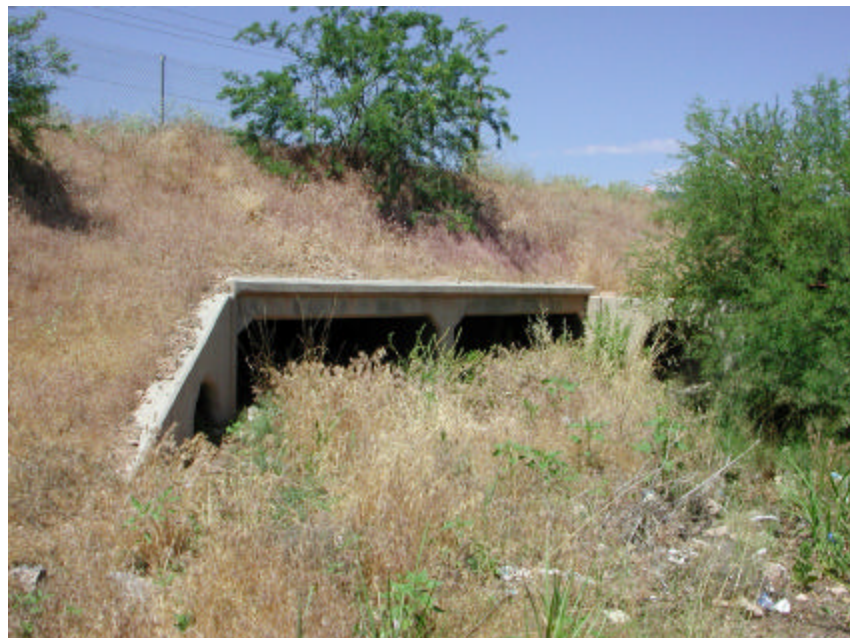
Outfall Identifier: 260-351.91
Description: 36" CMP outfall into west bank of Verde River Tributary north of SR-260.
Photograph orientation: Looking west into channel, pipe, and box culvert under highway.

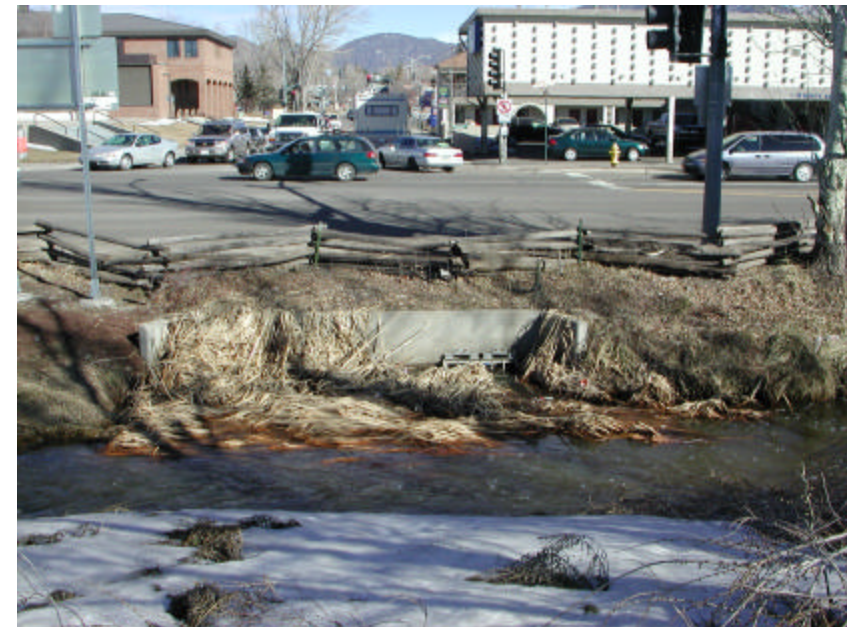
Outfall Identifier: B40-196.14
Description: 34" x 53" CMP outfall into north bank of Rio de Flag.
Photograph orientation: Looking north at intersection with US-180.

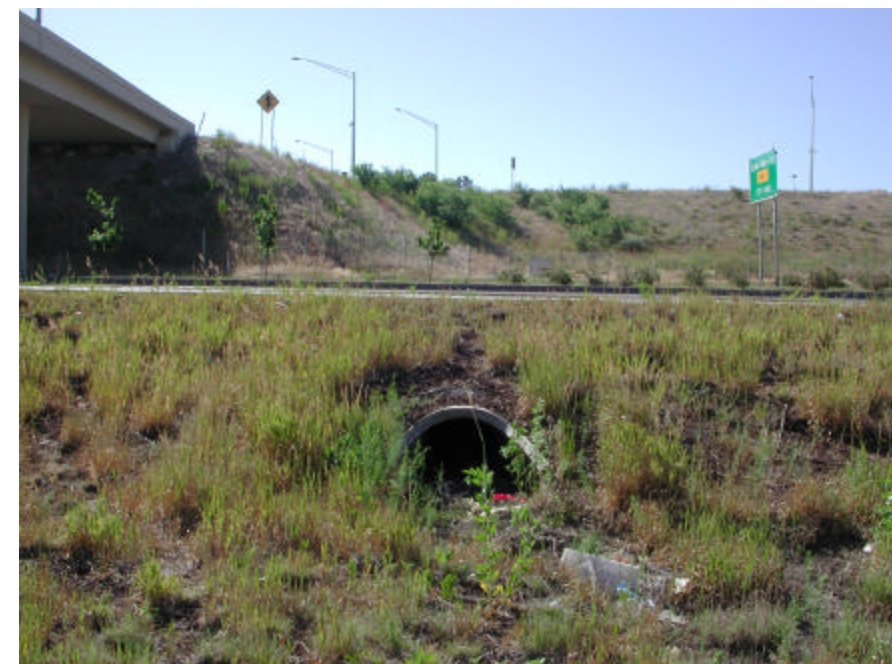
Outfall Identifier: 40-195.27
Description: 42" RCP south of I-40 west side of I-17 into east bank of Sinclair Wash.
Photograph orientation: Looking east into outfall.

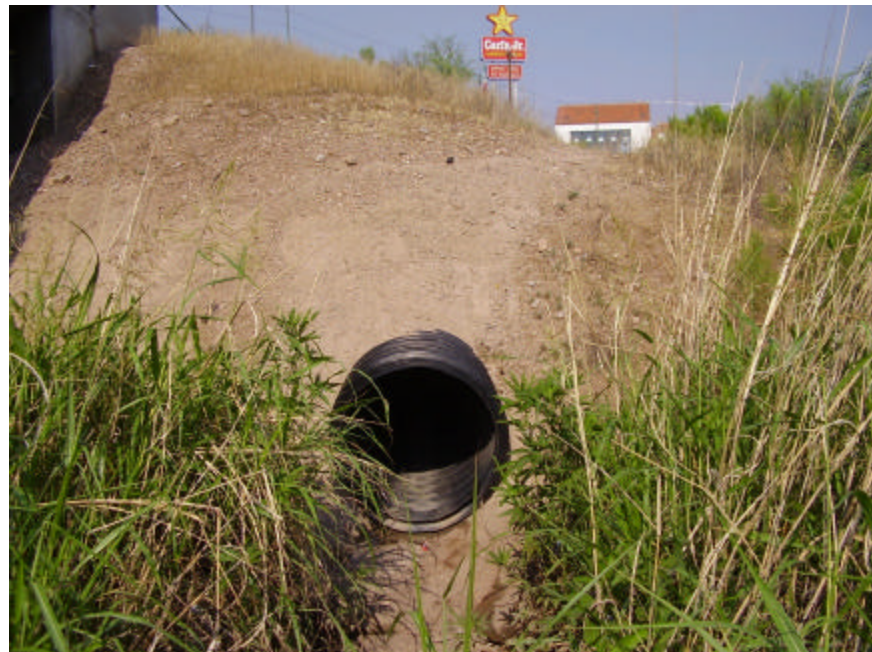
Outfall Identifier: 189-2.89
Description: 36" CMP outfall into west bank of Mariposa Wash north of SR-189.
Photograph orientation: Looking south into bridge embankment.

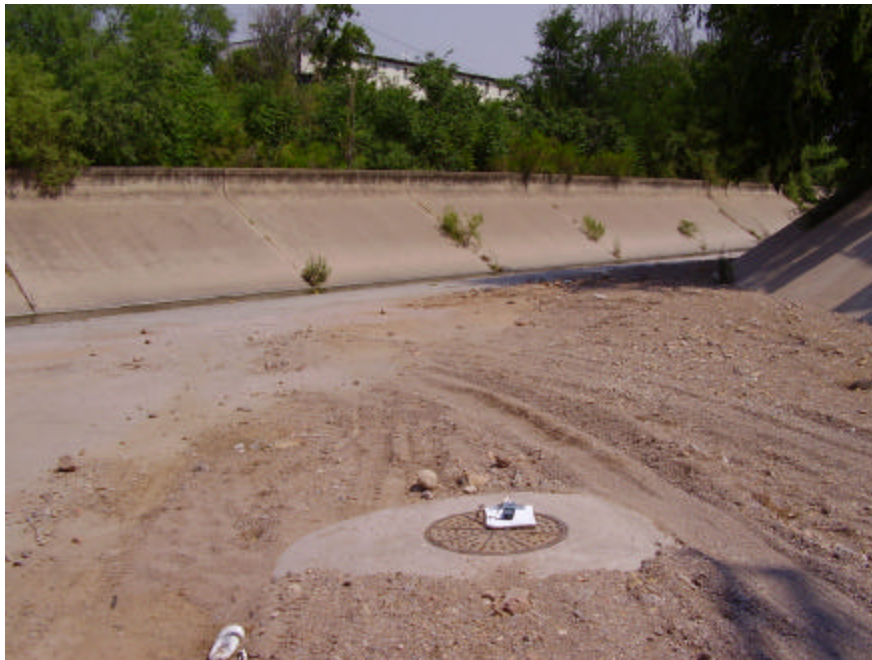
Outfall Identifier: 82-0.57
Description: Concrete lined wash outfall into Nogales Wash.
Photograph orientation: Looking east into outfall

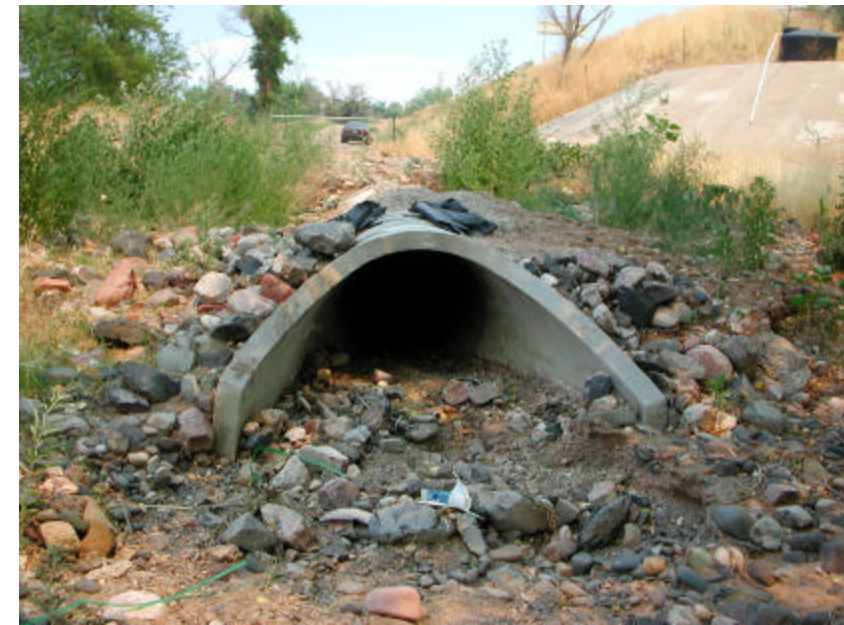
Outfall Identifier: 260-221.66
Description: 36" RCP into Verde River.
Photograph orientation: Looking north into outfall and Verde River Bridge.

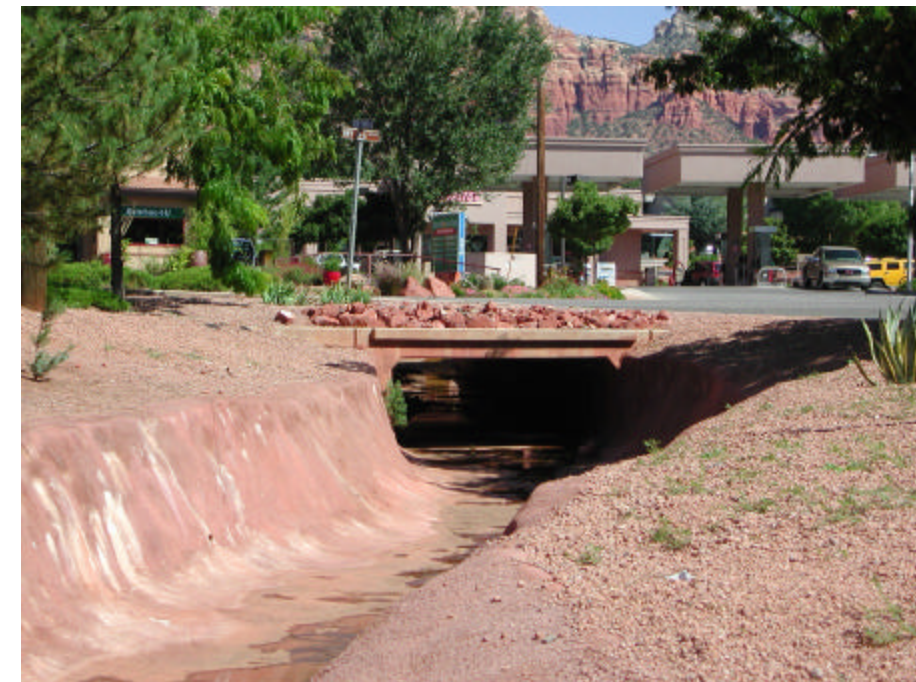
Outfall Identifier: 89A – 371.74
Description: 10' x 4' CBC into Tributary of Oak Creek.
Photograph orientation: Looking north into outfall.
